*This procedure was developed for orders 160031 and may not be applicable to all car types.
Please consult your original drawings or contact FreightCar America Inc. for details.*

Description – Addition of three reinforcement gussets to center partition to increase strength of cracked weld were center partition and cross ridge cap meet caused by corrosion.

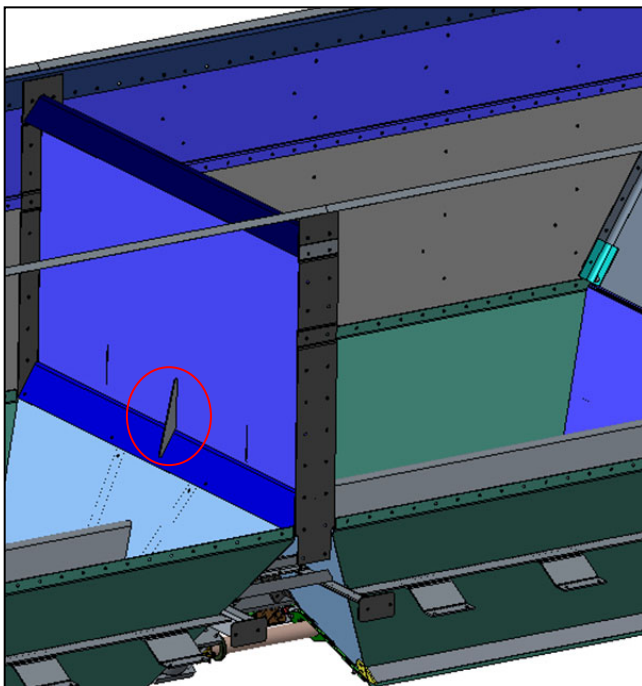
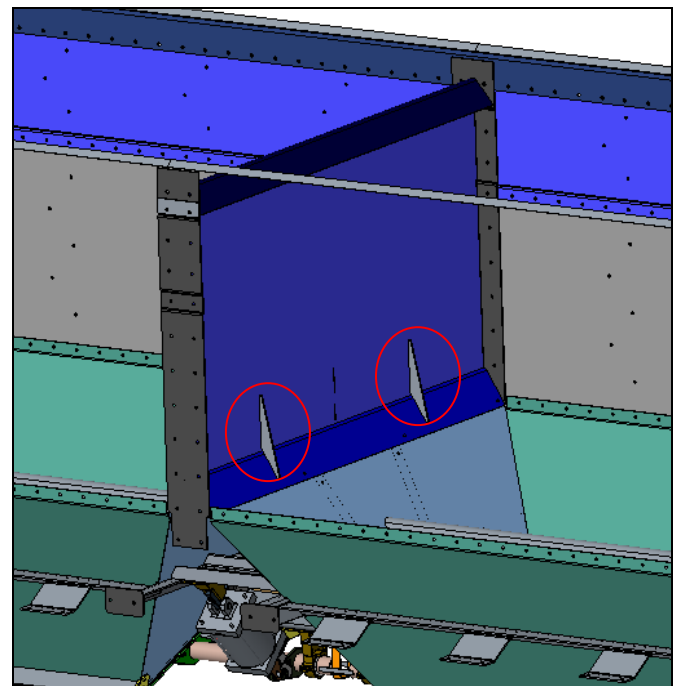
3D Model view of the reinforcement gussets on each side of the center partition. (Side sheet removed for clarity)

1. Clean all debris away were center partition and cross ridge cap meet. Both sides of partition.
2. Repair any cracks by grinding and rewelding center partition to cross ridge cap.
3. Position part number M116397-000 per drawings below. Areas must be ground and clean of corrosion.
4. One gusset centered one side and the other two spaced per dimensions below on the other side. (Doesn't matter which side the single or double gussets are placed)
