*This Procedure was developed as a **GUIDE** for evaluating damage to an aluminum top chord. Not all circumstances or combination of circumstances can be addressed; therefore good judgment in assessing damage is essential.*

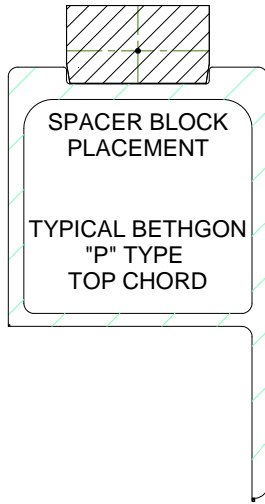
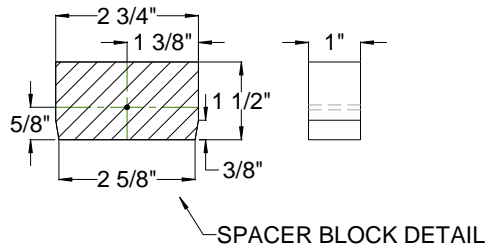
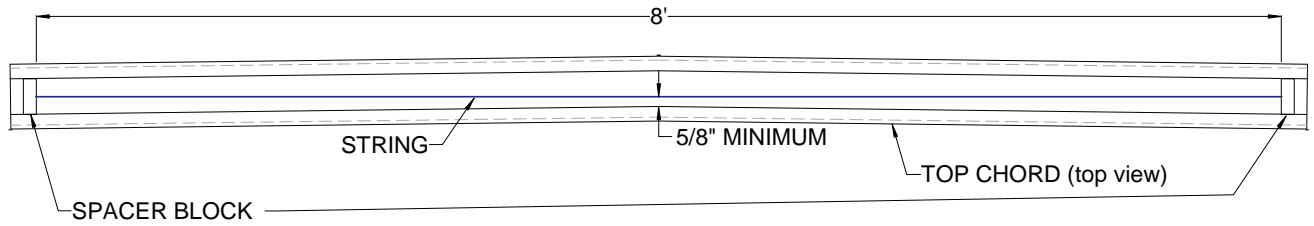
**SKETCH 1
METHOD TO INSPECT BENT TOP CHORD**

- 1). If a top chord is bent or bowed (and no other damage is present, i.e. interior bracing, side sheet buckling, etc.) so that the car exceeds the appropriate plate clearance, it should be replaced.
- 2). If a top chord has a localized buckle or offset (kink) of more than 3/4" in any 8 foot length it should be straightened & reinforced or replaced. Sketch 1 describes a method used to measure the offset of a BethGon "P" type top chord.
- 3). If a top chord is severely buckled, it should be replaced. See photo 1.
- 4). If a top chord cross section (i.e., dumper clamp damage)
 - a). is dented 1/2" or less no repairs are required. See Sketch 2. A localized reinforcement may be desired to minimize further damage.
 - b). is dented more than 1/2 " the top chord must be reinforced or replaced.

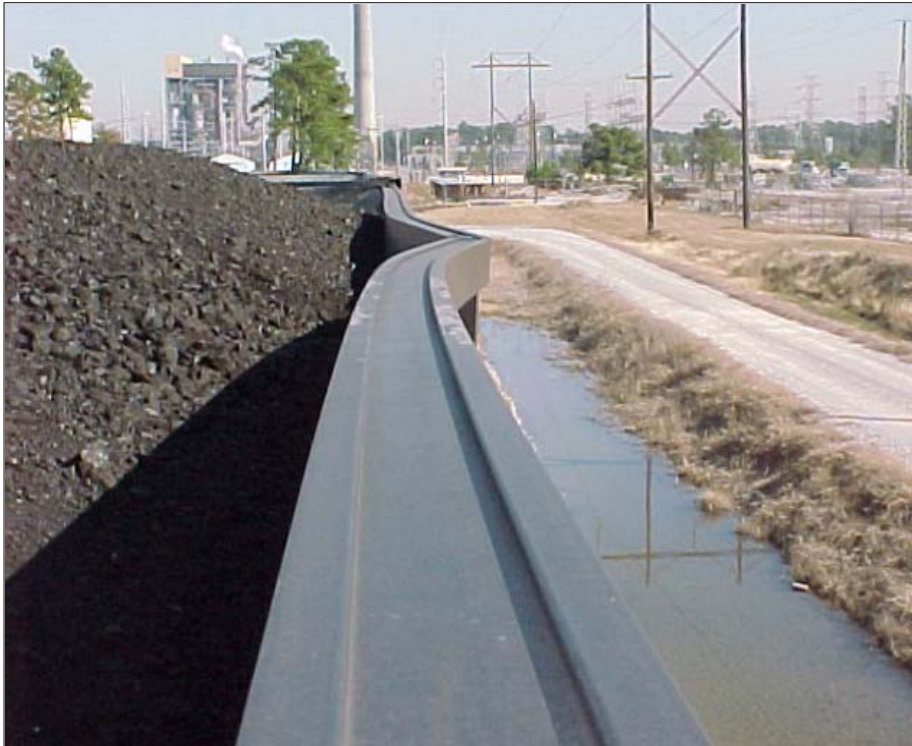
PHOTO 1 SEVERE BUCKLE
